Medallion Inspection Services

Confidential - Property Inspection Report - Confidential

12345 Somewhere St, Any City, Ohio
Inspection prepared for: John Doe
Date of Inspection: 2/10/2016

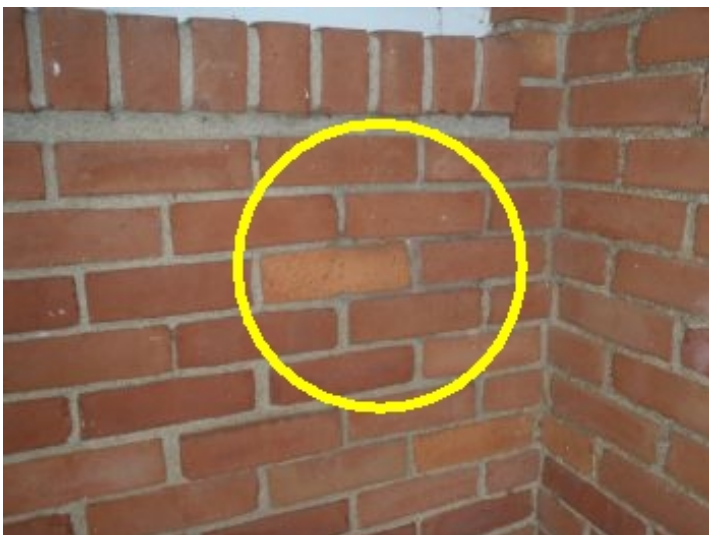
NE: Cracking at brick mortar joints. Recommend repairing and tuck pointing mortar joints as needed.

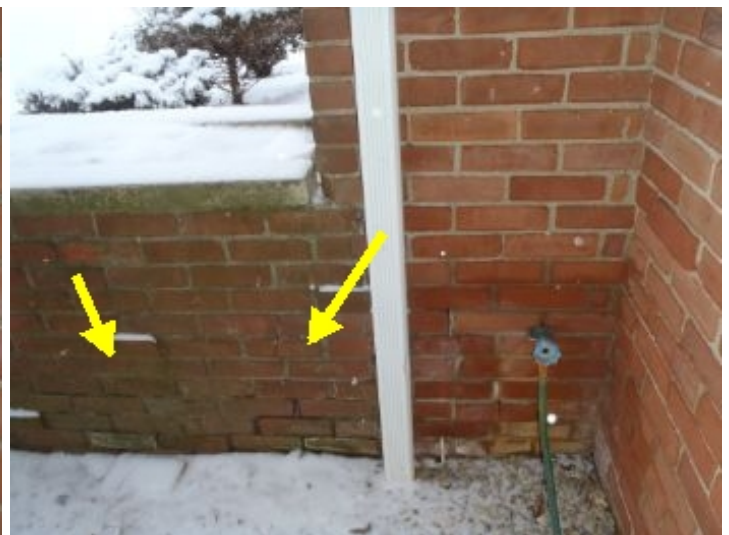
Front Door: Cracking at brick mortar joints. Recommend repairing and tuck pointing mortar joints as needed.

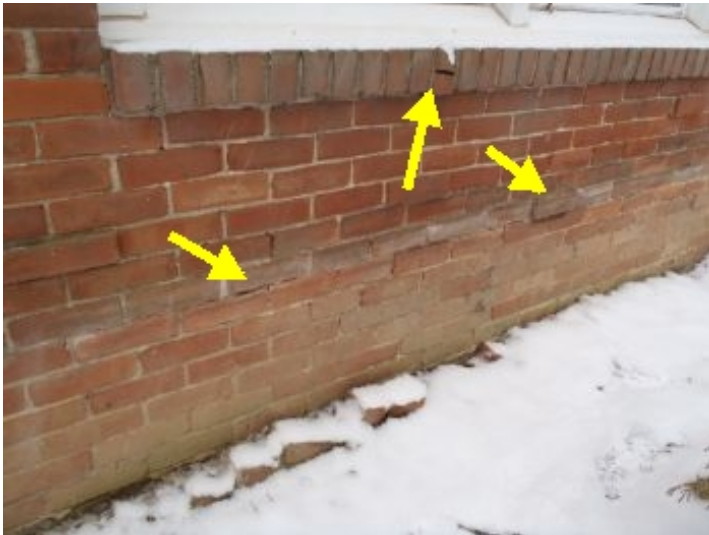
SE: Cracking at brick mortar joints. Recommend repairing and tuck pointing mortar joints as needed.

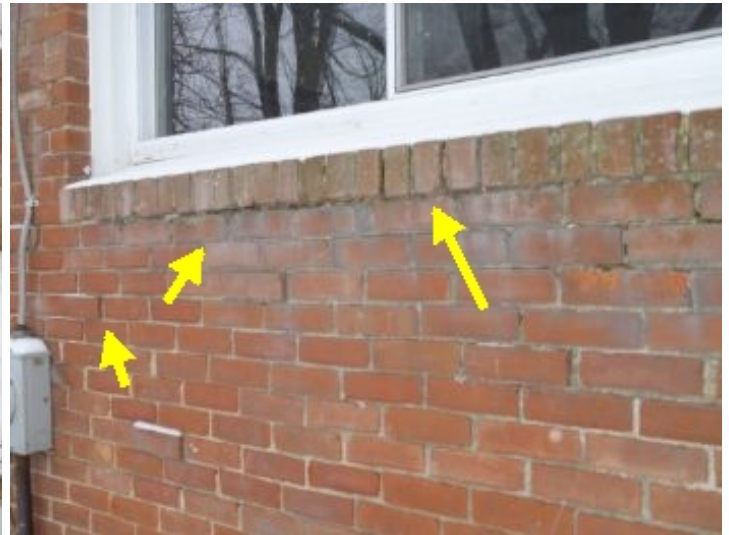
West: Cracking at brick mortar joints. Recommend repairing and tuck pointing mortar joints as needed.

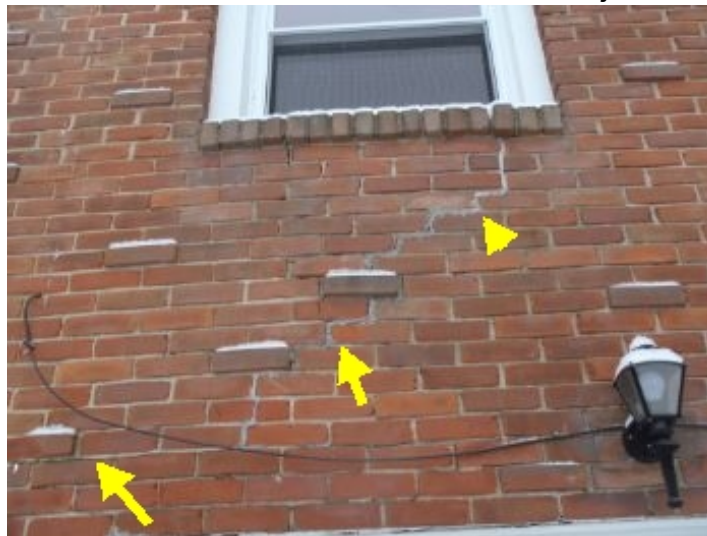
Cracking at brick mortar joints. Recommend repairing and tuck pointing mortar joints as needed.

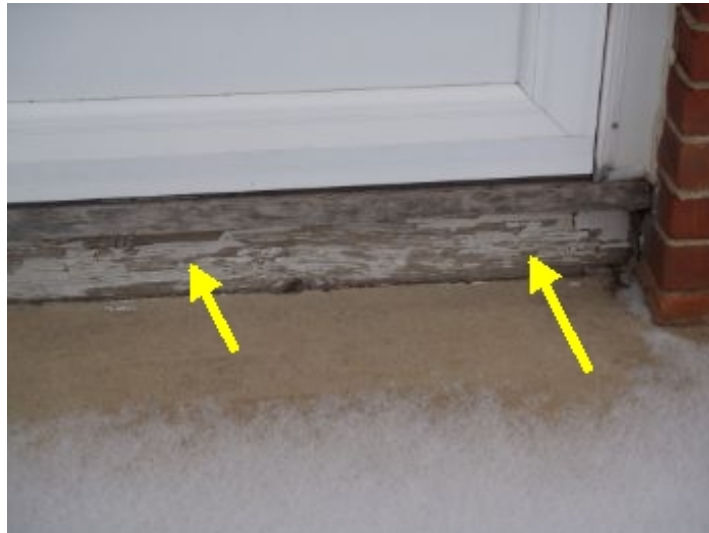
South Door: Exposed wood surfaces observed. Wood rot & deterioration can occur. Prep, prime and paint wood trim surface where paint is peeling or missing.

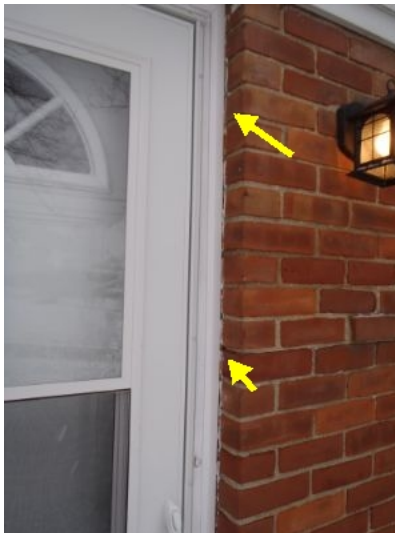
Caulking is recommended around windows/doors/masonry ledges/corners/utility penetrations.

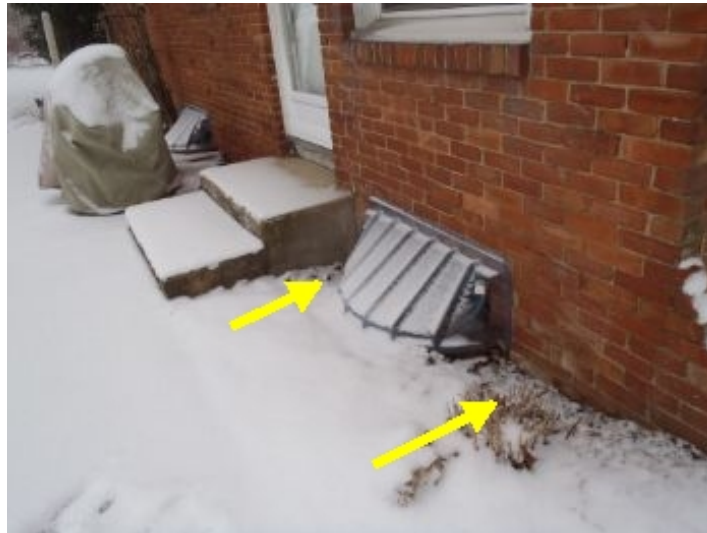
There are some low spots along the foundation. Recommend adding additional backfill to create the proper slope away from the house to allow for effective drainage.

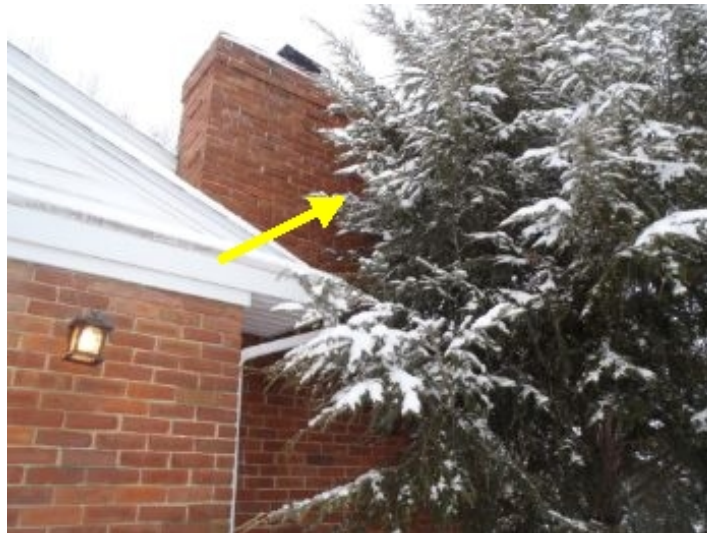
Recommend having vegetation trimmed, pruned, or removed from affected areas, and regular homeowner monitoring and landscaping maintenance thereafter.

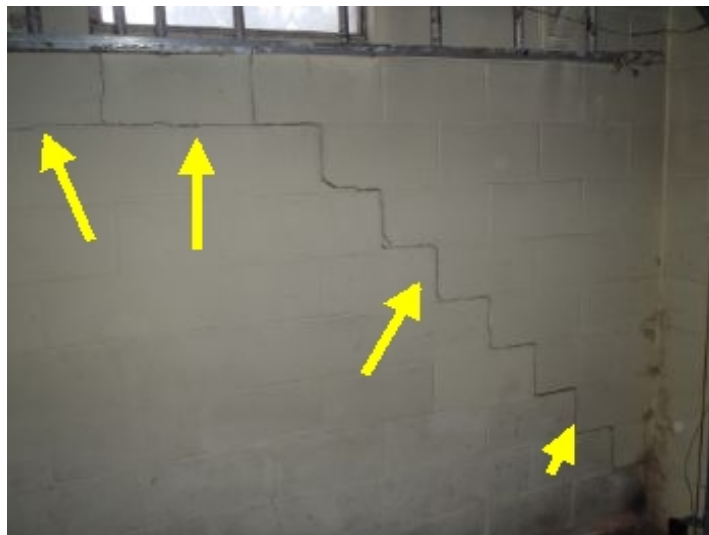
West wall: Foundation cracking was observed. This is usually the result of expansive soil, frost pressure or settling on the foundation. Lot drainage and foundation improvements should be addressed to keep water away from the building, and these cracks should be monitored. If additional movement occurs, repairs may be necessary. The rate of movement cannot be predicted during a one-time inspection. These cracks should be monitored for rate of movement.

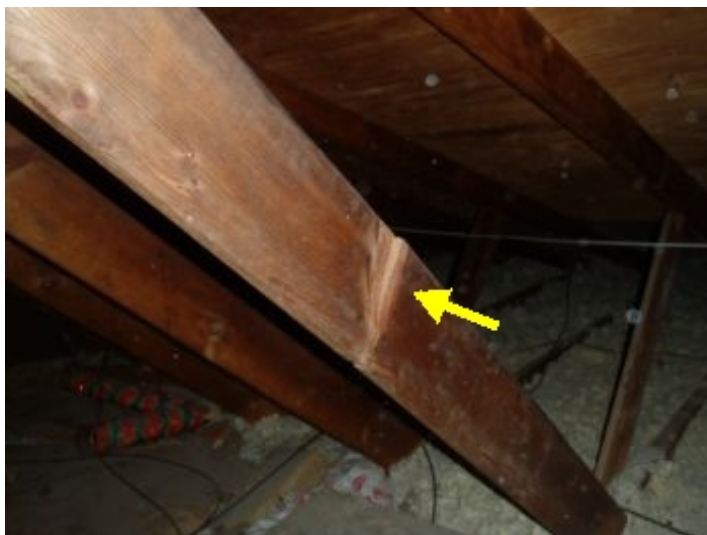
Just inside attic hole: Cracked truss brace, repair as needed.

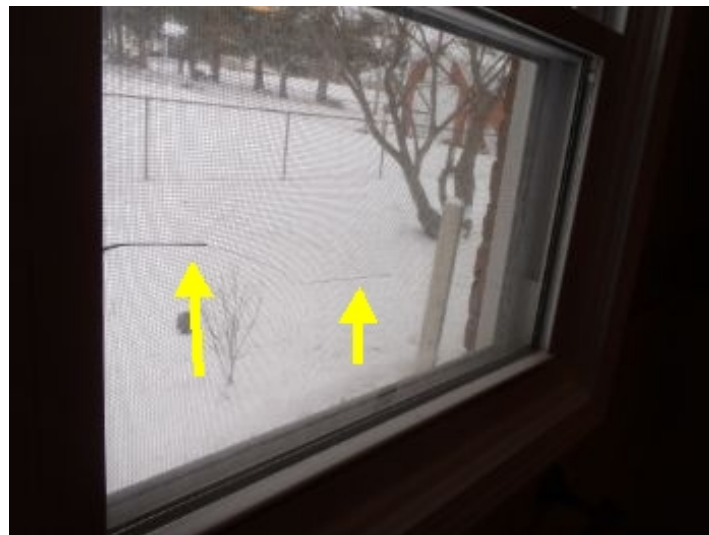
Bath #2: Cracked or broken window glass was observed. Injury could occur. Recommend repair or replacement of the damaged glass.

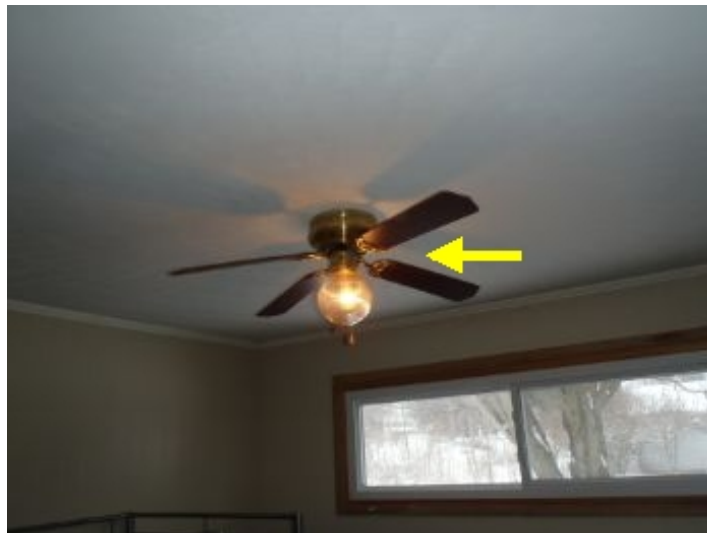
Ceiling fan in the bedroom 3 is abnormally noisy.

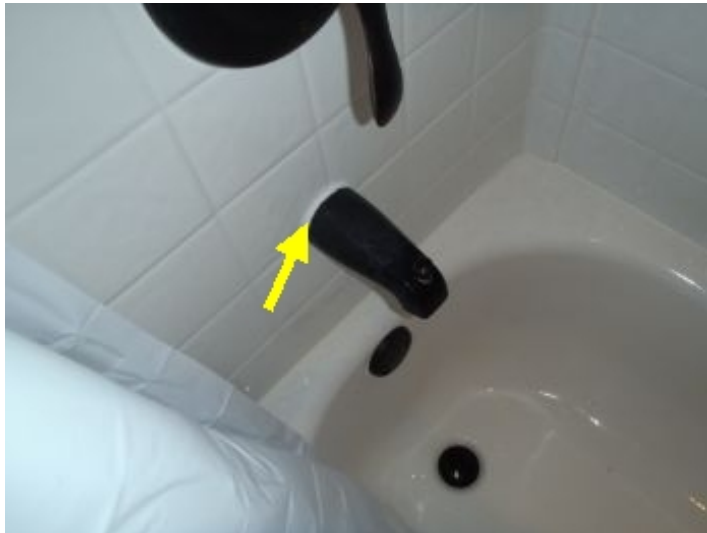
Tub spout is loose in bath 1, recommend repair as needed.

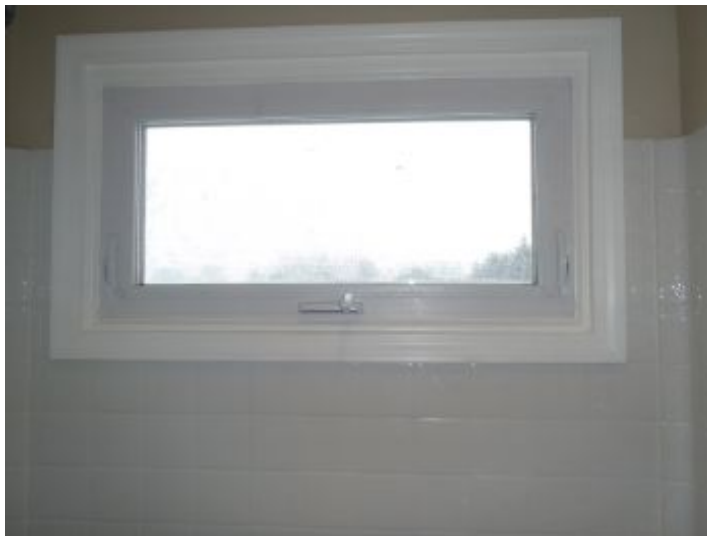
Recommend protecting shower window from water.

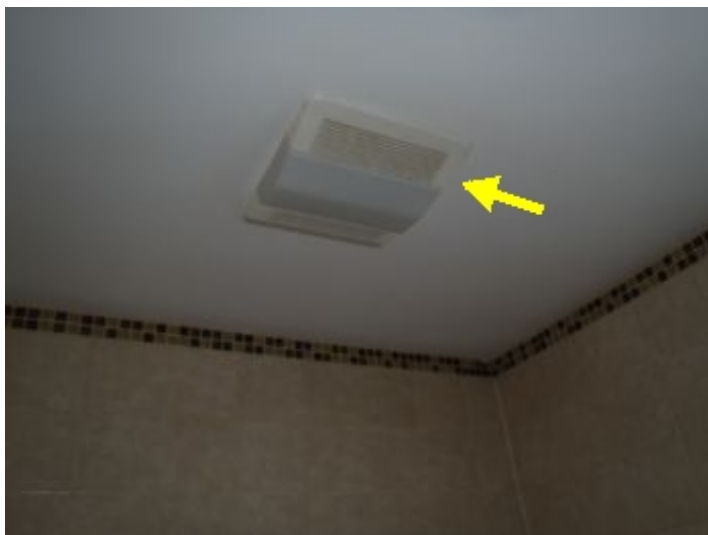
Bath 2: fan is loud, repair as needed.

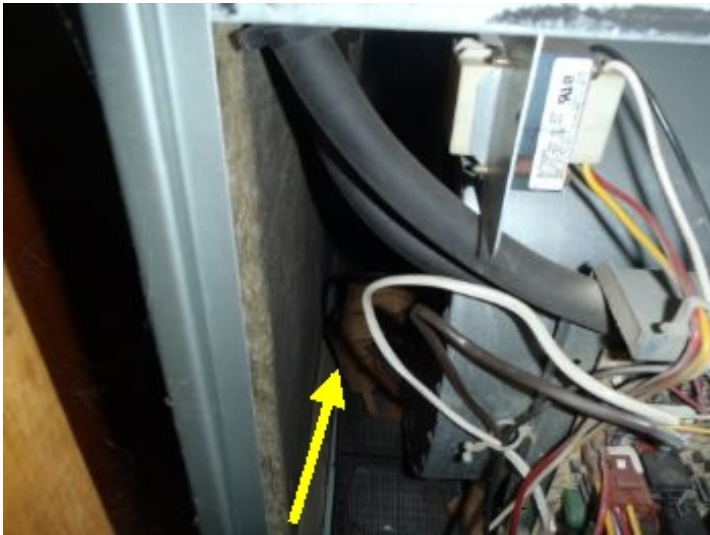
IMPROVE: The furnace is dirty and there are no records of prior service. Recommend an HVAC contractor perform a system Clean-and-Check. HVAC systems require yearly maintenance.

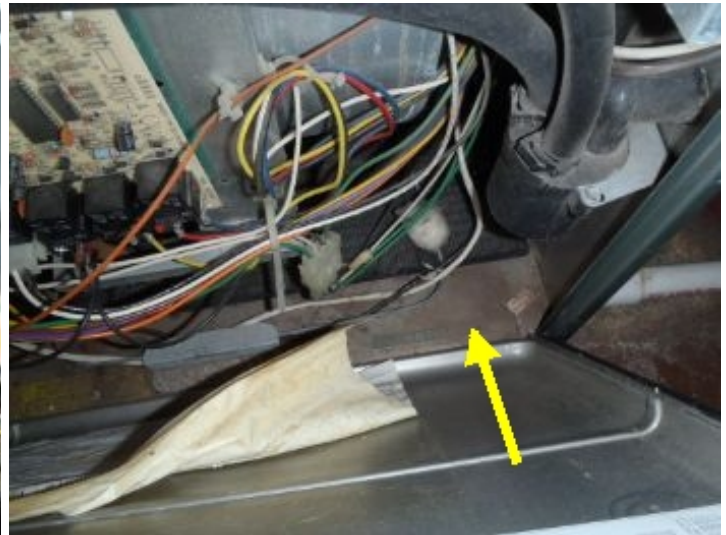
IMPROVE: The furnace is dirty and there are no records of prior service. Recommend an HVAC contractor perform a system Clean-and-Check. HVAC systems require yearly maintenance.

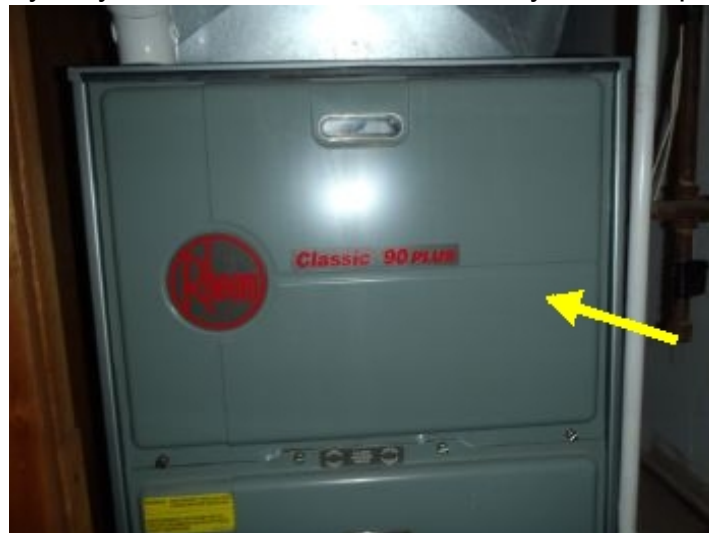
Upper door on furnace could not be removed, inspector could identify the year of manufacture or inspect furnace completely. Recommend HVAC tech repair as needed.

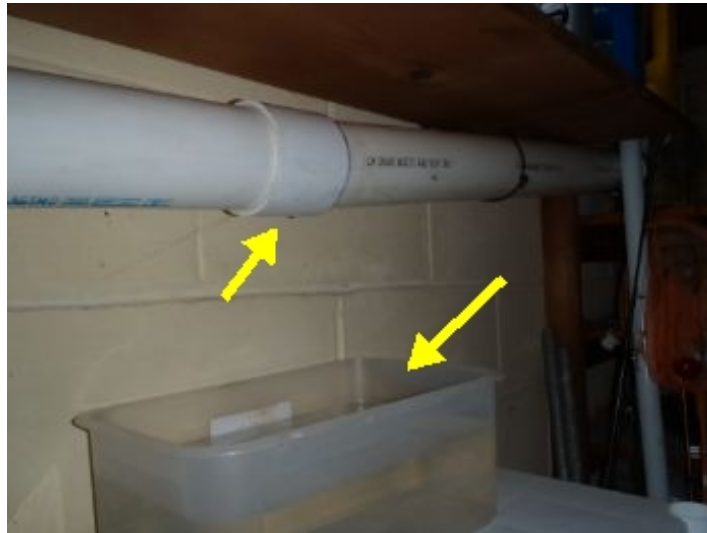
SAFETY CONCERN: Hole observed in furnace vent pipe. Repair as needed

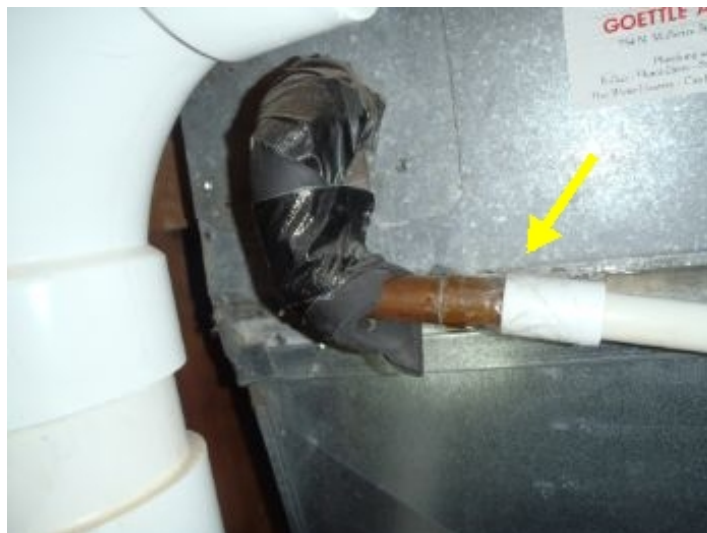
Handy man drain connection, recommend repair as needed.

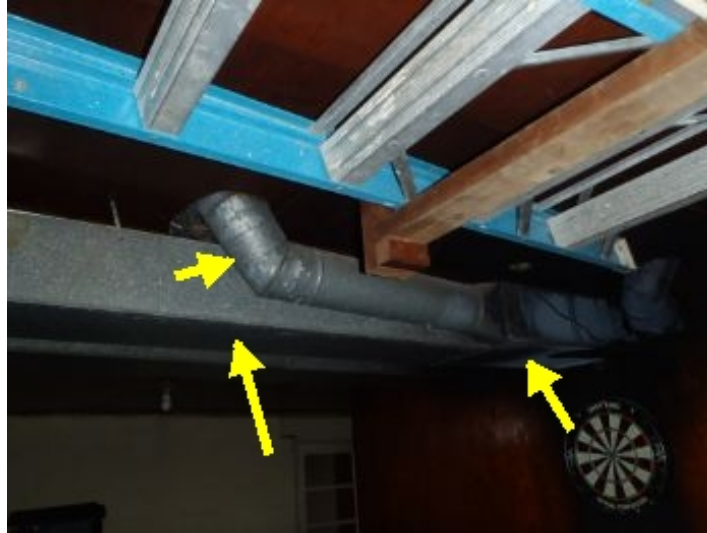
Lower temperatures at bedroom 2, insulation of garage heat runs may help.

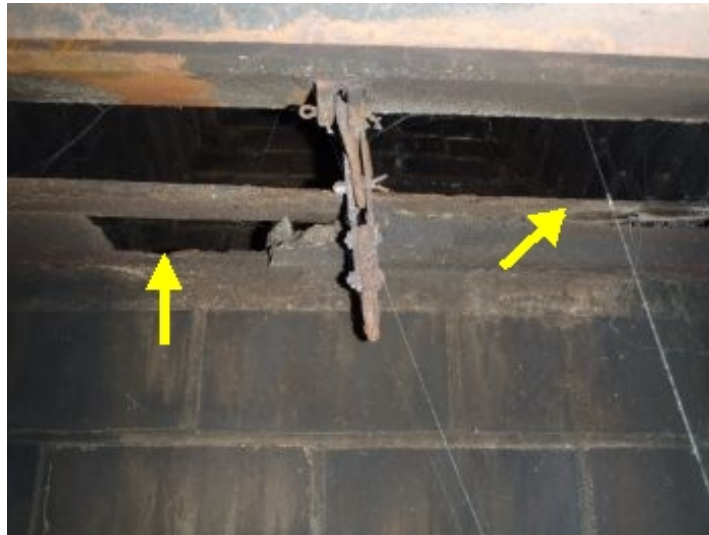
The damper did not operate when tested, sections are rusted, repair as needed.

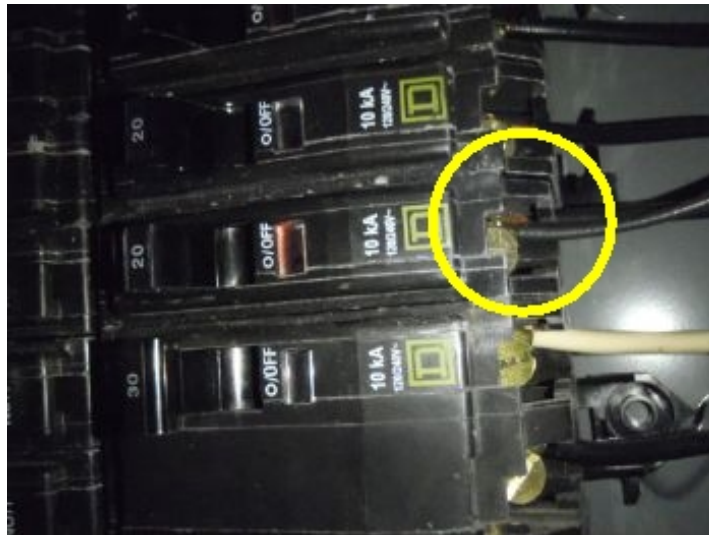
"Double Tapping" observed on one or more circuit breakers--two wires on single breaker. These breakers appear not to be rated for double tapping. Qualified electrician should evaluate and repair as necessary.

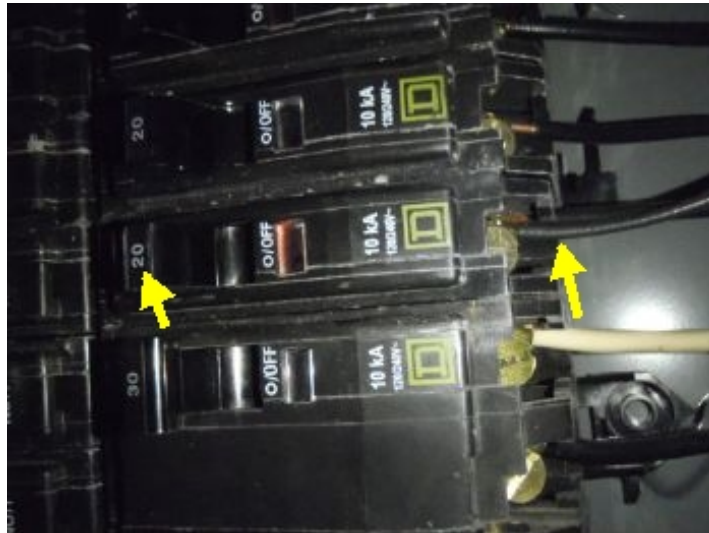
One oversized breaker in main panel.

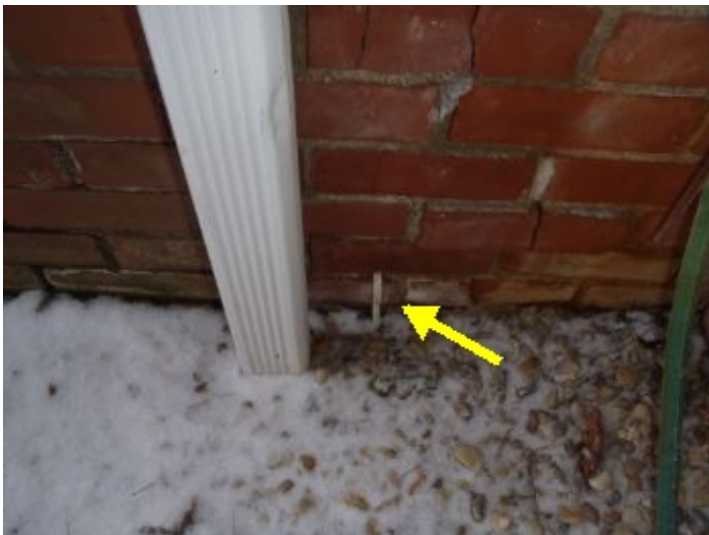
The wiring located nest to front door is susceptible to damage. It is recommended a licensed electrician review for proper installation.

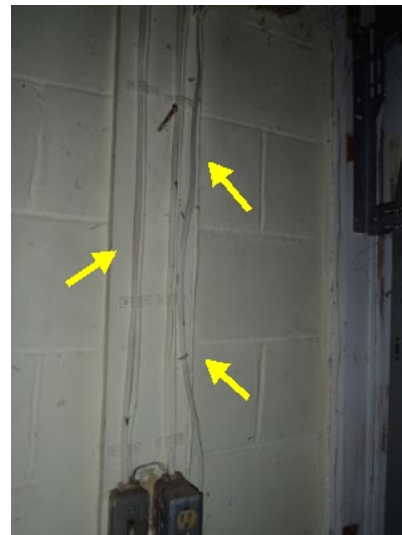
The wiring located in the basement and garage is susceptible to damage. It is recommended a licensed electrician review for proper installation.

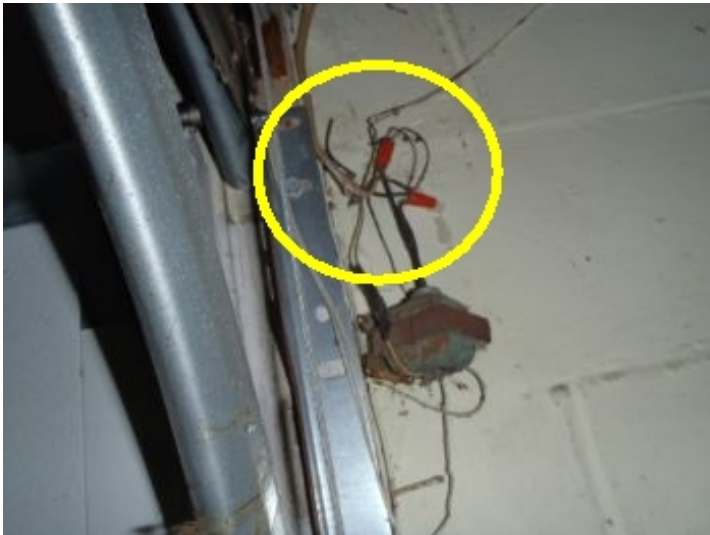
There is an open splices in the East garage door.
Licensed electrician repair as needed.

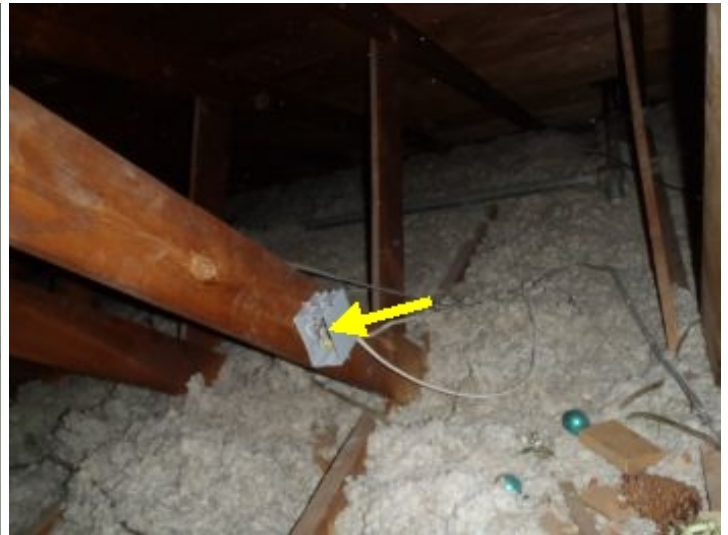
Missing junction box cover in attic. Repair as needed.

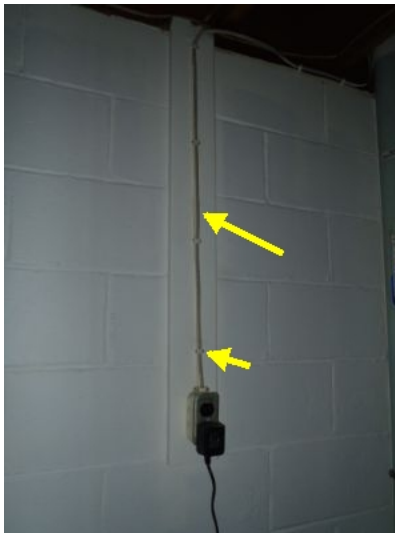
The wiring located in the basement and garage is susceptible to damage. It is recommended a licensed electrician review for proper installation.

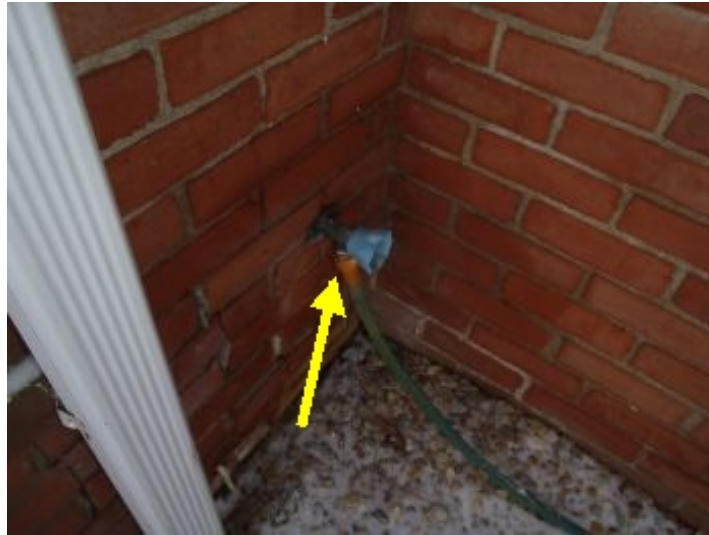
Recommend removing hose during colder months

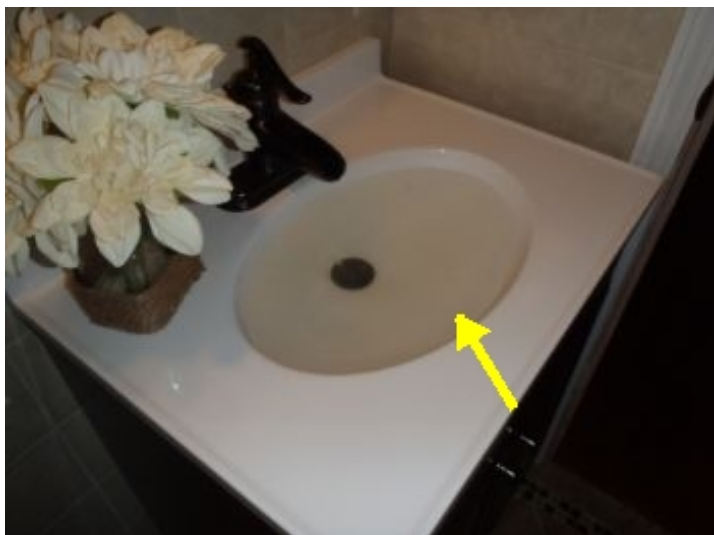
A slow draining sinks in #2 bathroom is normally due to a clogged trap. Disassembly and cleaning of the trap is the most effective correction. Plumber recommended.

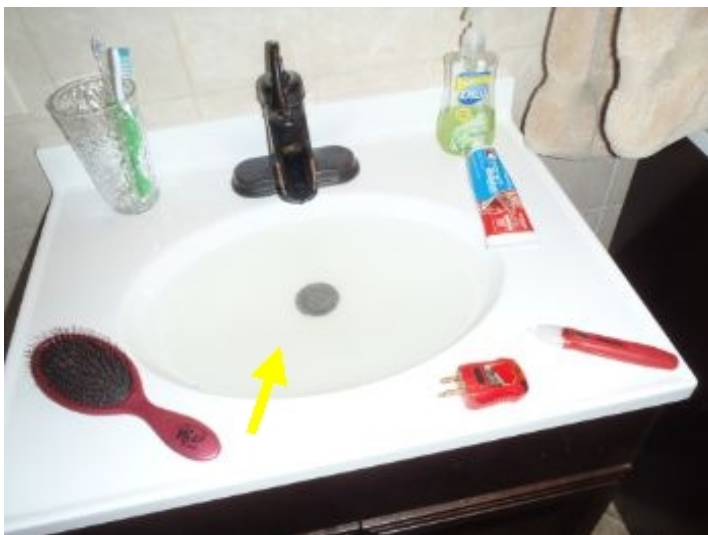
A slow draining sinks in #2 bathroom is normally due to a clogged trap. Disassembly and cleaning of the trap is the most effective correction. Plumber recommended.

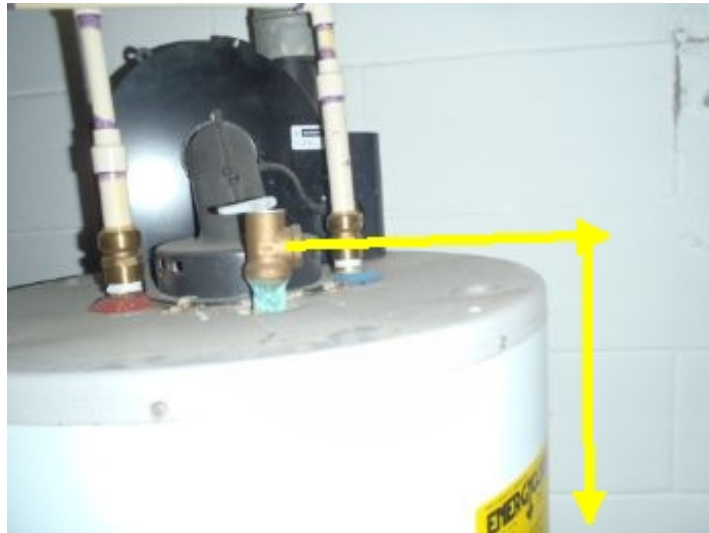
The extension at the water heater relief valve is missing. This is a potential scalding concern as water can discharge improperly. Recommend installing the proper type of relief extension to discharge within 6" from the floor.

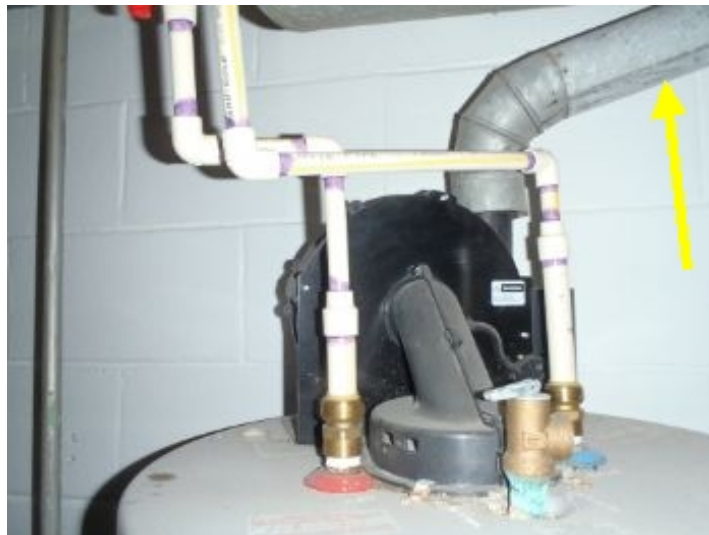
Metal vent not recommended for power vent water heater. Recommend plumber review and repair as needed.
